# LEHIGH COUNTY AUTHORITY SANITARY SEWER OVERFLOW REPORT

LLRI - MANHOLE # B6

LEHIGH COUNTY AUTHORITY

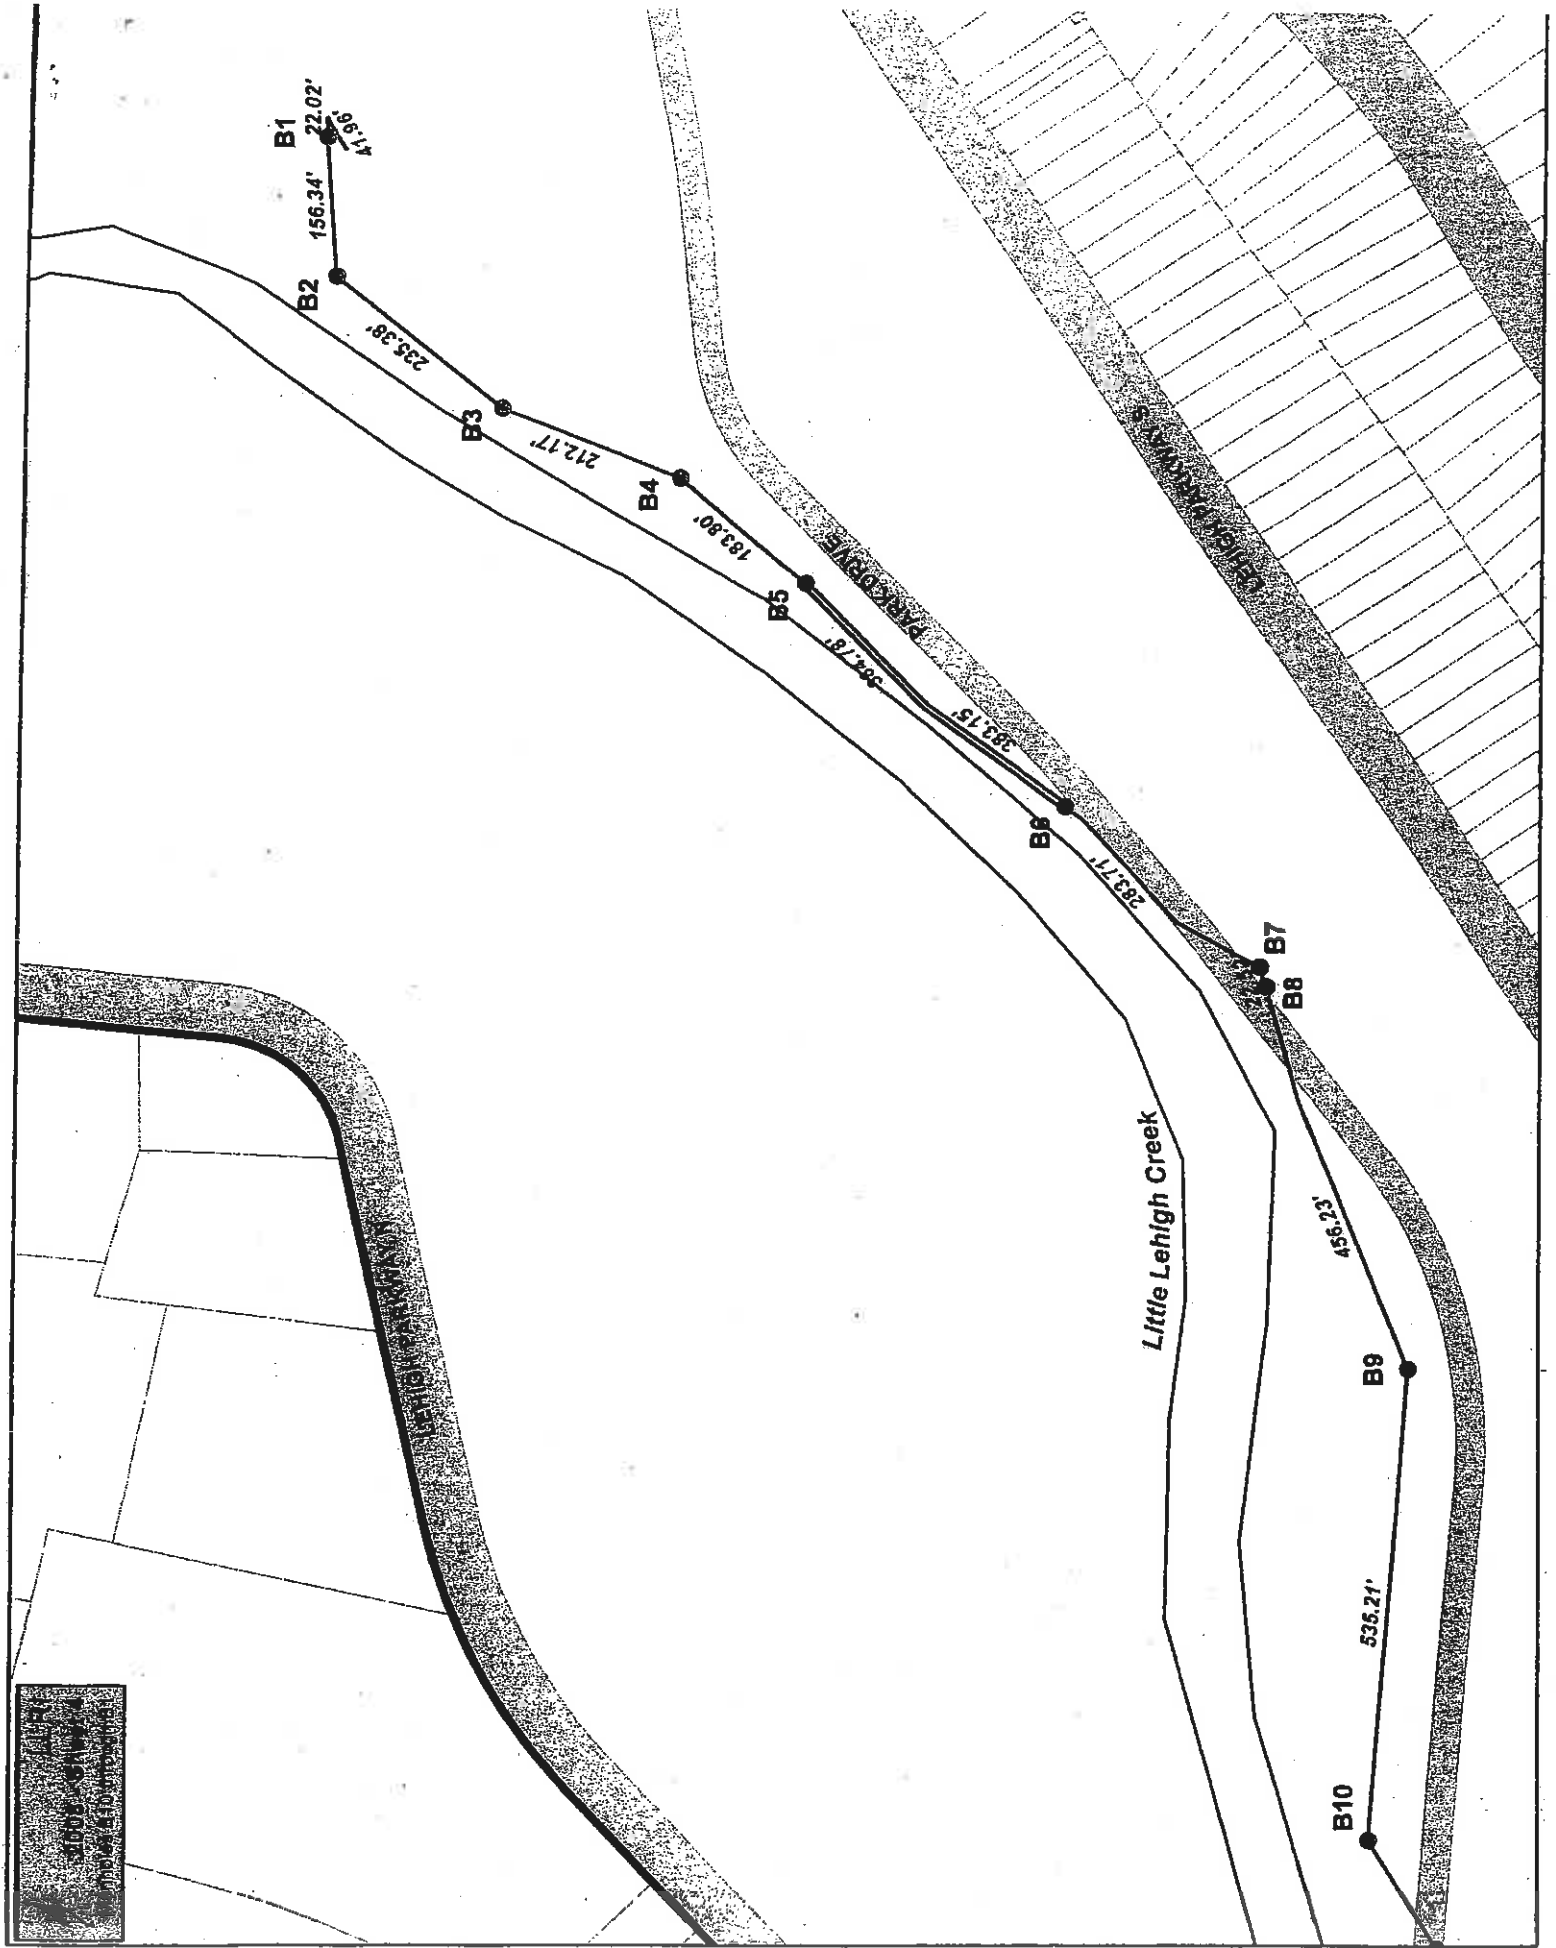
Manhole No.	Location	Time	Observation	Distance to Flow (ft./in.)	Operator Ints.	Pic #
B1	LLRI	8:00	NO LEAKS			
B2	LLRI	8:10	NO LEAKS			
B3	LLRI	8:20	NO LEAKS			
B4	LLRI	8:30	NO LEAKS			
B5	LLRI	8:40	NO LEAKS			
B6	LLRI	8:45	MINIMAL OVERFLOW AT THIS TIME 1-5 GAL.	10'	B.G.	610
B7	LLRI	8:50	NO LEAKS			
B8	LLRI	8:55	NO LEAKS			
B9	LLRI	8:57	NO LEAKS			
B10	LLRI	9:00	NO LEAKS			
B11	LLRI	9:03	NO LEAKS			
B12	LLRI	9:05	NO LEAKS			
B13	LLRI	9:10	MINIMAL OVERFLOW BUBBLING	30'	B.G.	609
B14	LLRI	9:20	BUBBLING	30'	B.G.	608
B15	LLRI	9:25	NO LEAKS			
B16	LLRI	9:30	NO LEAKS			
B17	LLRI	9:40	NO LEAKS			
B18	LLRI	9:45	NO LEAKS

Manhole No.	Location	Time	Observation	Distance to	Operator	Pic #
				Flow (ft./in.)	Ints.	
B19	LLRI	9:46	NO LEAKS			
B20	LLRI	9:48	NO LEAKS			
B21	LLRI	9:50	NO LEAKS			
B22	LLRI	9:53	NO LEAKS			
B23	LLRI	9:55	NO LEAKS			
B24	LLRI	9:57	NO LEAKS			
B25	LLRI	10:00	UNDERWATER?			
B26	LLRI	10:02	NO LEAKS			
B27	LLRI	10:10	NO LEAKS			
B28	LLRI	10:20	NO LEAKS			
B29	LLRI	10:25	NO LEAKS			
B30	LLRI	10:30	NO LEAKS			
B31	LLRI	10:33	NO LEAKS			
B32	LLRI	10:38	NO LEAKS			
B33	LLRI	10:43	NO LEAKS			
B34	LLRI	10:49	NO LEAKS			
B35	LLRI	10:53	NO LEAKS			
B36	LLRI	11:05	NO LEAKS
